Le Vie dei
Mercanti

XXI INTERNATIONAL FORUM

Transform of Traditional Urfa Houses Located in the Historical Area of the City

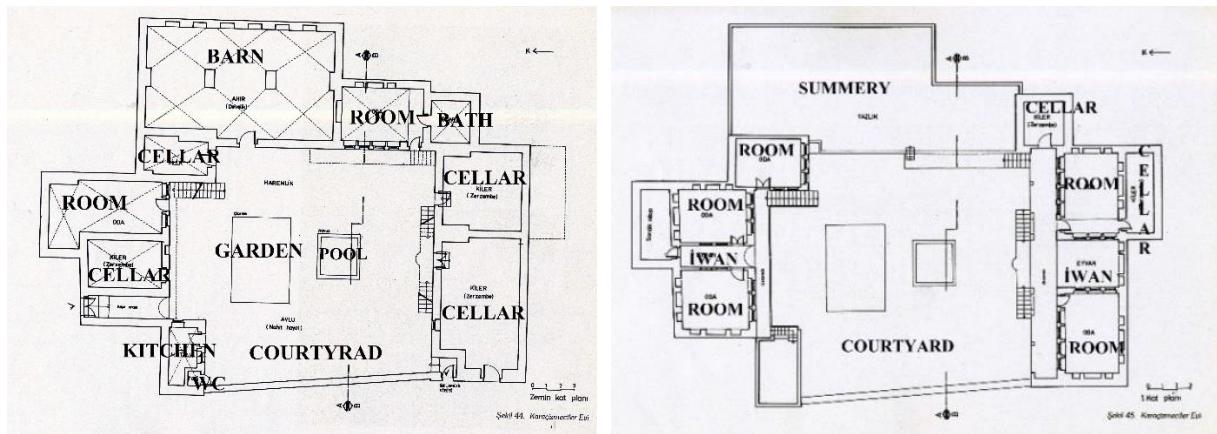
Fig. 1: Plan of Karacizmeliler House (Hanehan Boutique Hotel) (prepared based on the plan obtained from SKVKK archive)

The functional units that shape traditional Urfa houses are the courtyard, iwan, rooms, and service areas such as "tandırlık" (kitchen), "develik" (stable), "zerzembe" (cellar), and "hela" (toilet) (Fig. 1).

a. Groundfloor plan

b. 1st floor plan

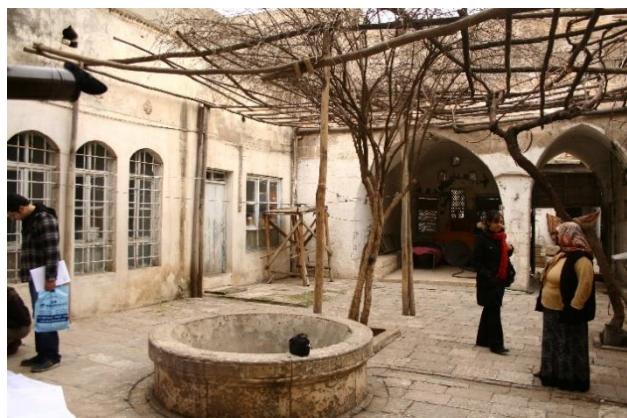
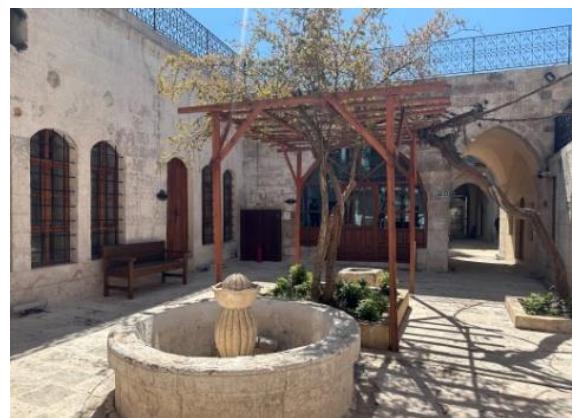
Fig. 2: One of the courtyards in Vilayetler House Hotels

In the region dominated by hot climate, houses are shaped around a courtyard (Fig. 2). The size and shape of the courtyards, which are actively used for seven to eight months of the year, are defined according to the size and shape of the parcel and houses. The courtyard floor is covered with cut stone with dimensions of 40x50 cm. Usually, there is a small garden in the courtyard where a pool, a well, and various fruit trees such as pomegranate and fig trees grow. In some buildings, there are two separate courtyards, one for women's quarters and one for men's quarters.

a. Before restoration

b. After restoration

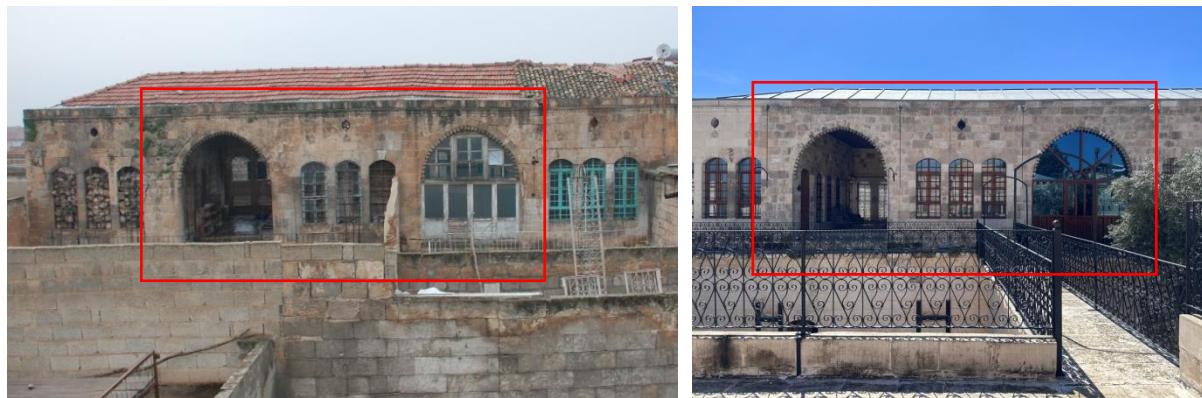
Fig. 3: An example from the iwans in Vilayetler Evi Hotels

One of the most important factors shaping traditional architecture is the climate. The hot and dry climate of the Urfa region has also shaped the traditional housing form. The iwan is a semi-open space created by the hot climate (Fig. 3). The space, which is rectangular in plan, is usually designed with rooms on both sides. Corner iwans are also found in some buildings. The iwans on the ground floor are built a few steps higher than the courtyard level. In the iwans built on the ground floor, the windows of the rooms on both sides of the iwan can face the iwan and their doors open to the courtyard. On the upper floor, the windows as well as the doors of the iwans can be opened towards the iwan (Fig. 4-c). There are also examples where the doors do not open to the iwans. Upper floor iwans that face the street have windows on the sides and back. The surface of the iwans facing the courtyard is arched (Fig. 9). In addition, there are late period iwan types divided by one or two columns in front of them (Fig. 9-e).

a. Before restoration

b. After restoration

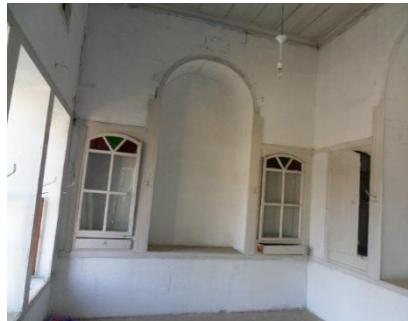
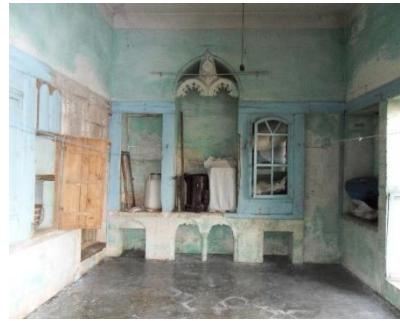
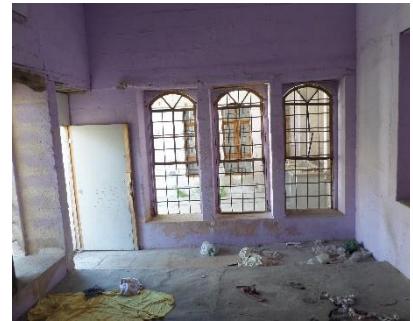
Fig. 4: Examples of rooms found in traditional Urfa houses

Rooms where activities such as sitting, working, eating, and sleeping take place are built with square or rectangular plans (Fig. 4). At the entrance of the rooms, there is a "gedemeç" area where shoes are taken off, which is 20-25 cm lower than the floor level and 100-110 cm wide, sometimes extending along the room facade and sometimes made as a square.

The niches located on one or several walls of the rooms with high ceilings add liveliness to the room (Fig. 4). Additionally, there are cabinets and built-in niches called "camhane" in the rooms (Fig. 4 a-b). The floors of the rooms are paved with smooth cut stone. The uppercovering of the rooms on the groundfloor is generally a diagonal vault, and there is less use of timber beams as the uppercovering on the groundfloor. On the upperfloors, timber beams are mostly used as the uppercovering. In front of the rooms on the upper floor, a walking platform carried by stone consoles, which is open at the top and provides access to the rooms, has been built (Fig 9a-b-f).

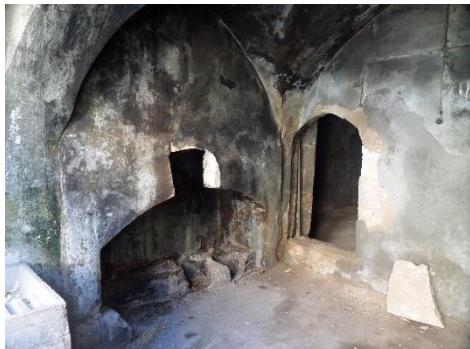
Fig. 5:Hasbahan Hotel/ Before restoration

The tandırlık (kitchen), located in the harem section of the house, opens directly onto the courtyard. It is the area where daily and seasonal meals are prepared. It contains a stove for cooking food (Fig. 5) and niches for placing food containers. It is covered with a cross-vault. The wall facing the courtyard is constructed with hollow spaces to allow for air circulation.

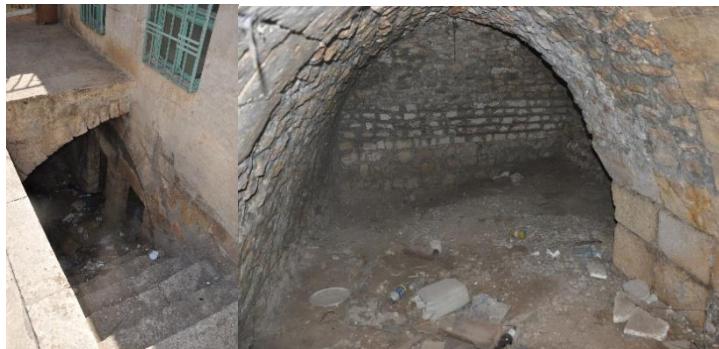
Fig. 6: Nahrin Hotel/ Before restoration

This is the most significant service area of the house. This space, where winter foods are stored, is designed below the ground level to keep it cool (Fig. 6). It is generally rectangular and covered with a crossvault.

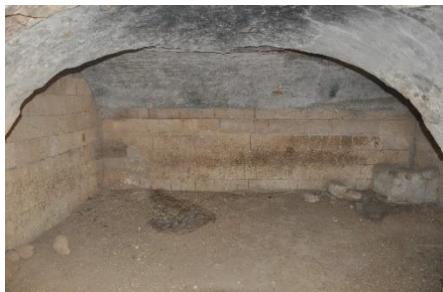
Fig. 7: Nahrin Hotel/ Before restoration

These are the areas where animals are kept and are located near the entrance on the ground floor (Fig. 7). They are generally rectangular in shape and covered with a crossvault.

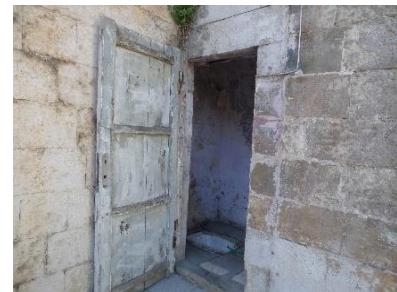
Fig. 8: Hanehan Boutique Otel

In somehouses, they are located in the courtyard, while in others they are located in the space between the outerdoor and the innerdoor called "doorway". The "hela" that opens to the courtyard can be locatedunder the stairs, in one corner of the courtyard, or on a wall of the courtyard (Fig. 8).

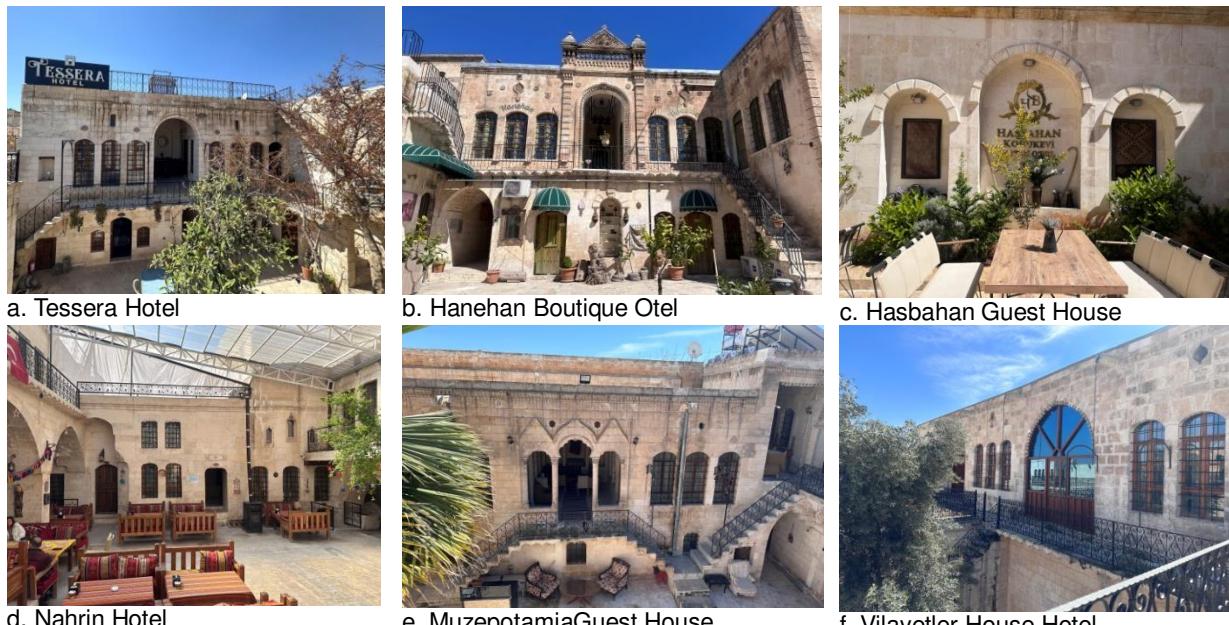
Fig. 9:The boutique hotels that were examined

In recent years, the increase in the number of tourists has created a need for accommodation in the city of Sanliurfa. In order to utilize the abandoned and deteriorated housing stock in the historical center of the city, with the support policies of the Ministry of Culture, traditional houses in the historical city center have been converted into boutique hotels. According to the data obtained from SKVKBK, the number of structures converted from traditional houses to boutique hotels for this purpose is 47, of which 24 are currently in use. As part of the study, six of these buildings were examined on site: Tessera Hotel, Hanehan Boutique Hotel, Hasbahan Guest House, Nahrin Hotel, Muzepotamia Guest House, and Vilayetler HouseHotel(Fig. 9).

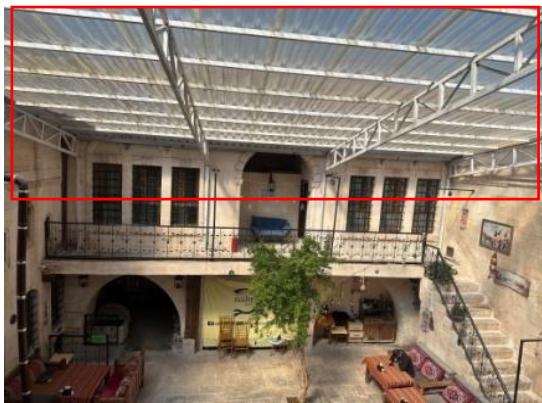
Fig. 10: Nahrin Hotel

In the transformation of traditional buildings into boutique hotels, it has been observed that in some buildings, the courtyard, which is the main element shaping the residences, is partially or completely covered (Fig. 10). Cameras, modems, and other devices have been added to the courtyards (Fig. 11), and in some buildings, fans have been added to the courtyard facade to provide coolness in the summer (Fig. 12).

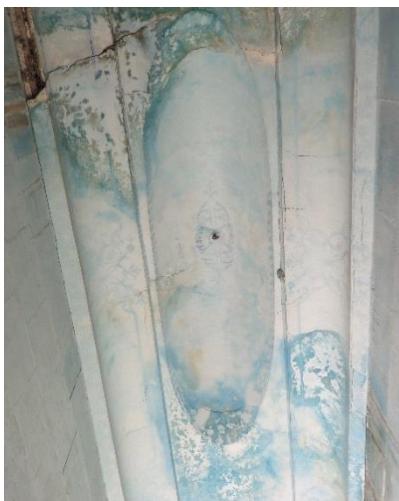
In some buildings where traditional houses are converted into boutique hotels, the iwan, a semi-open space created by hot climate conditions, has been completely enclosed. In some buildings, the back wall of the iwan has been brought forward to create a wet area for the rooms (Fig.). In the building formerly known as the Karacizmeliler House and now operated as the Hanehan Boutique Hotel, the decorations on the ceiling of the eyvan have not been restored to their original state due to reasons such as a shortage of skilled craftsmen (Fig. 13). In some buildings, a fan has been added to the eyvan ceiling to provide coolness in the summer (Fig. 14).

Fig. 13: Before and after restoration

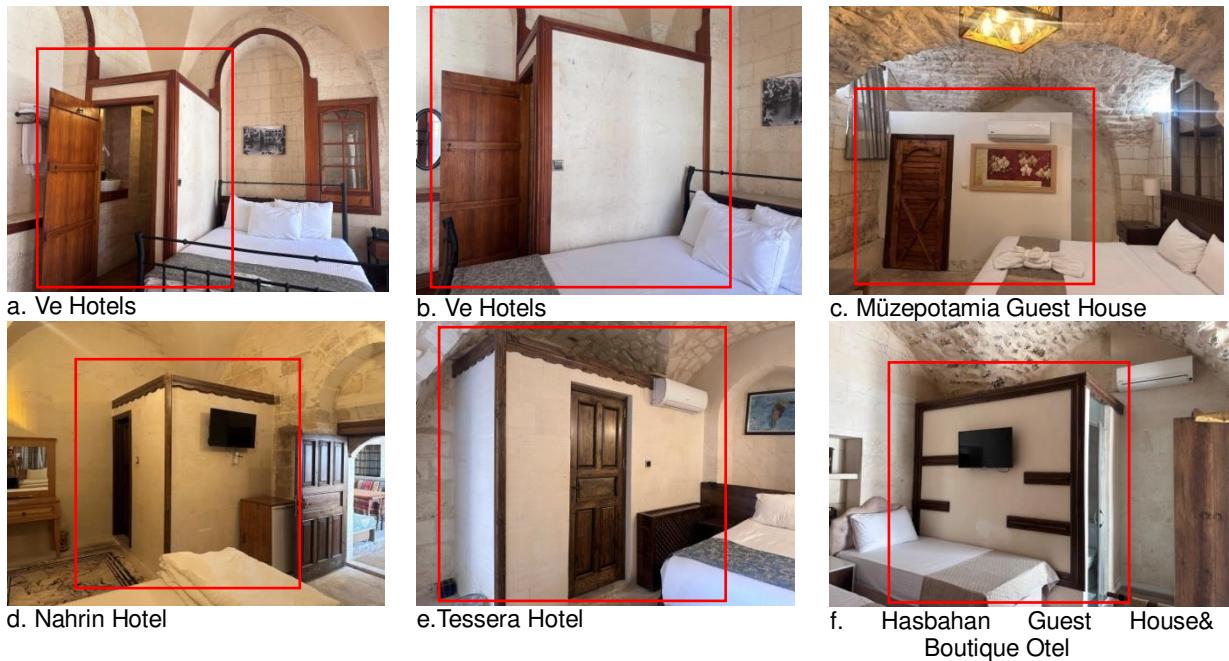
During the conversion of traditional buildings into boutique hotels, the biggest change seen in the rooms is the addition of wet areas in line with modern living conditions. Wet areas, which should be made of removable materials, have been added to some rooms in a corner of the room (Fig. 15). In some rooms, they have been extended from the floor to the ceiling on one side of the room (Fig. 16). In some rooms, they have been designed along the facade, but the walls have been raised to a certain height and covered (Fig. 17). In some rooms around the iwan, wet areas have been added by pulling the back wall of the iwan forward (Fig. 18).

Fig. 15: Added wet areas in room corners

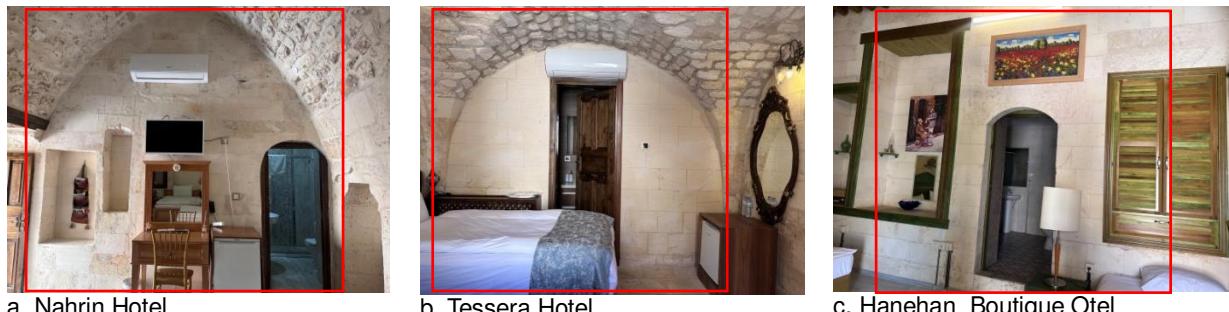
Fig. 16: Examples where wet areas are added along the room facade and the walls are raised up to the ceiling

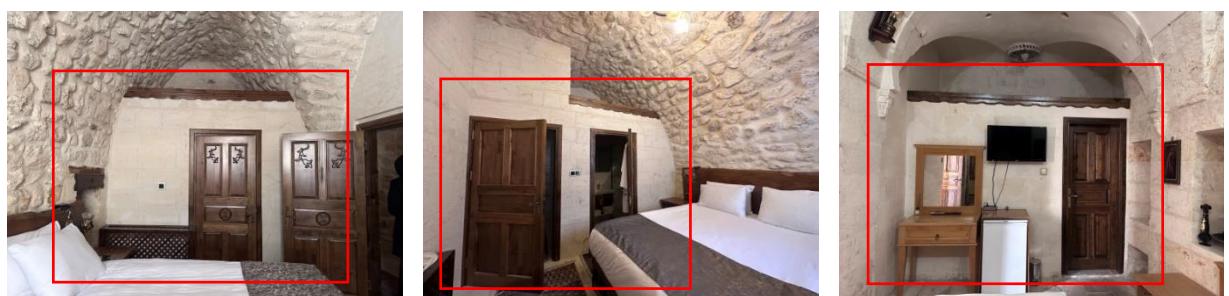
Fig. 17: Examples of wet areas added along the room facade and with walls raised to a certain height include

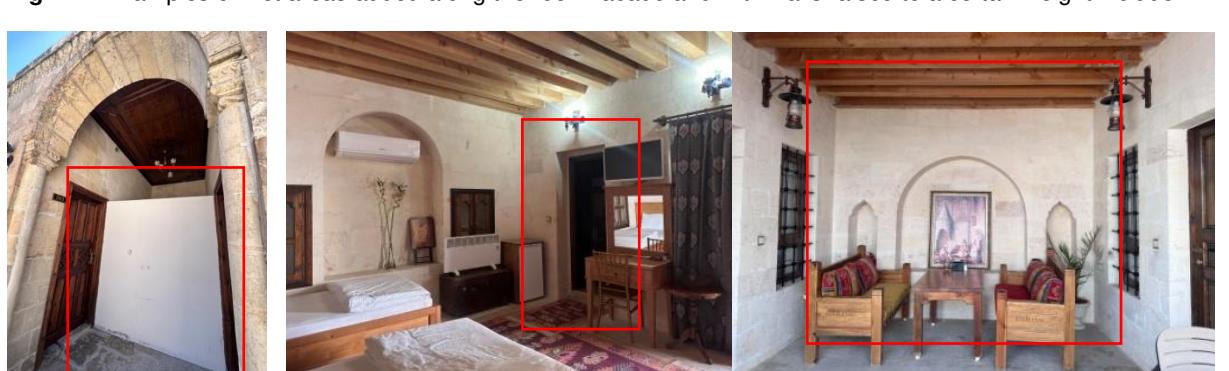
Fig. 18: The wet areas added to the back wall of the iwan

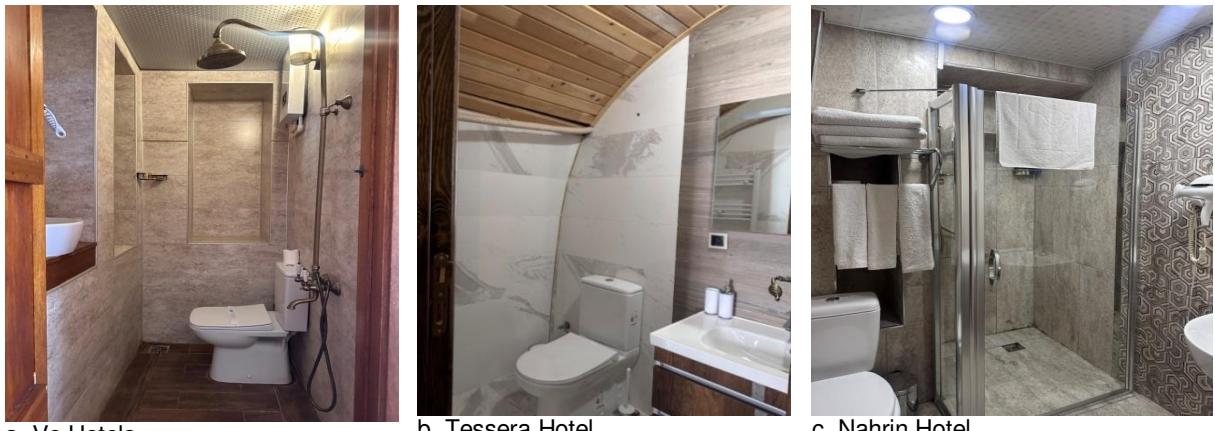
It has been observed that in the examined examples, the wet volumes are added to conform to current conditions in terms of materials, usage, etc., but they are incompatible with the traditional texture (Fig. 19).

a. Ve Hotels
b. Tessera Hotel
c. Nahrin Hotel
Fig. 19: Examples from the wet areas added to the rooms

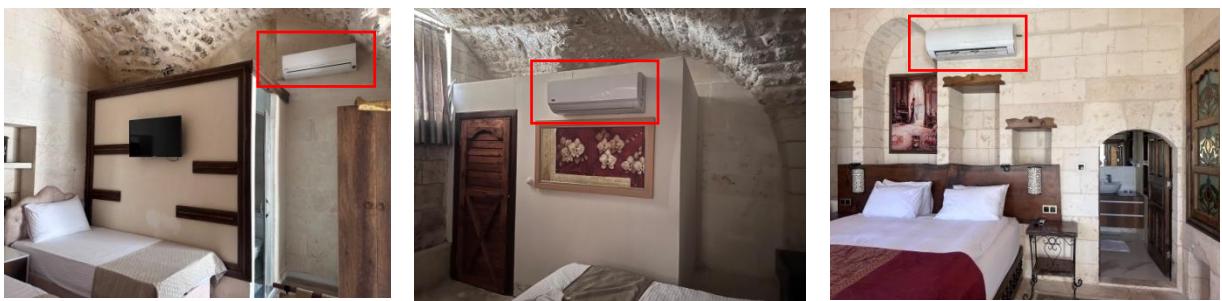
It has been observed that airconditioning units have been added to most of the rooms (Fig. 20). In addition, interventions such as converting niches and/or windows into doors/niches into windows have been detected in the rooms.

a. Hasbahan Guest House & Butik Otel
b. Müzeopotamia Guest House
c. Tessera Hotel
Fig. 20: Air conditioners added inside the rooms

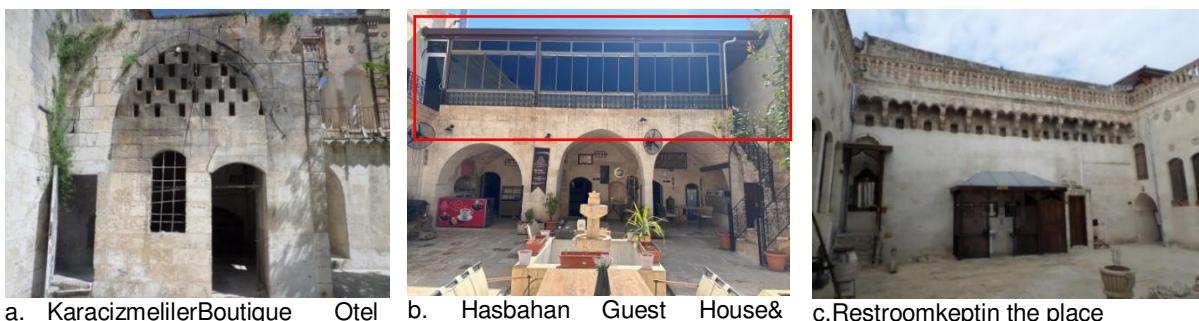
Tandırlık(kitchen) spaces are mostly used as kitchens again(Fig. 21a). There have also been cases where they are used as hotel rooms. The spaces like the cellar, stable with a rectangular plan and usually covered with a cradle vault located half a floor below ground level are used for the boutique hotel's breakfast room needs. There are also instances where hotels have converted the upper part of their terrace and/or courtyard into a covered space to serve as a breakfast room for their guests (Fig. 21b). The original restrooms in the building are generally preserved due to their functional use(Fig. 21c).

a. Karacizmeli Otel
b. Hasbahan Guest House & Boutique Otel
c. Restroom kept in the place
Fig. 21: Interventions Made to Other Units
